Longborough HLO20, The Monarchs Way, Gloucestershire, Cotswolds.

Before and after photos

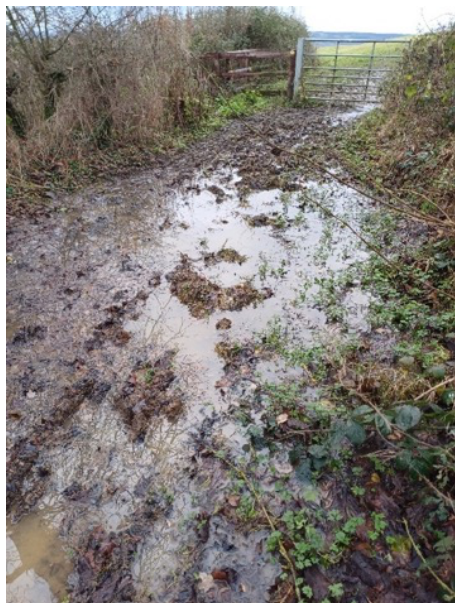
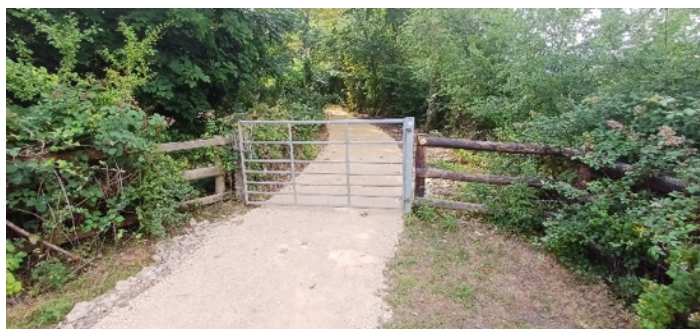
Above: The worst section at the top of the path where a year-round puddle had formed obstructing passage by anyone wearing less than wellies has been scraped, regraded and stoned with a fall to the side so any water is shed rather than captured as standing water on the path.

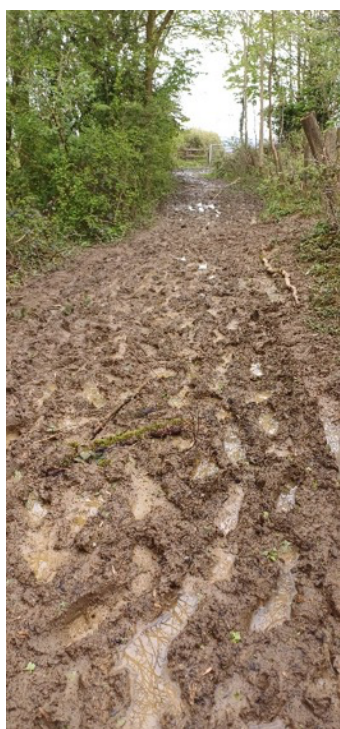
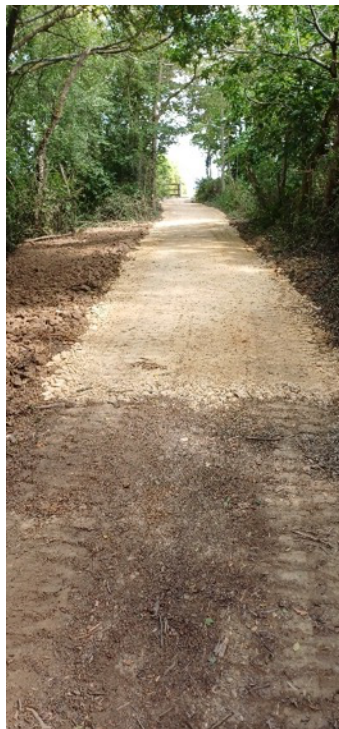
Below: the muddy approach to the gateway has also been scraped and regraded and stoned.

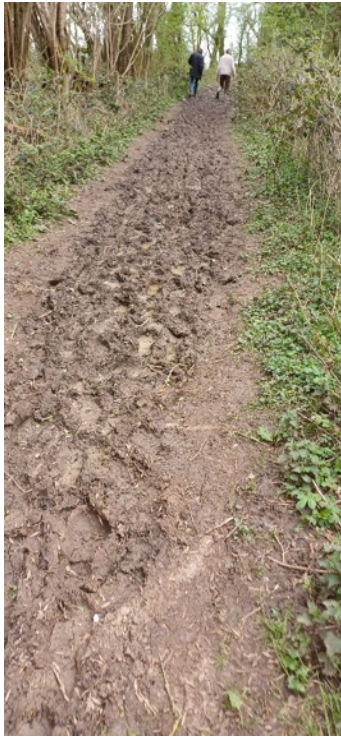
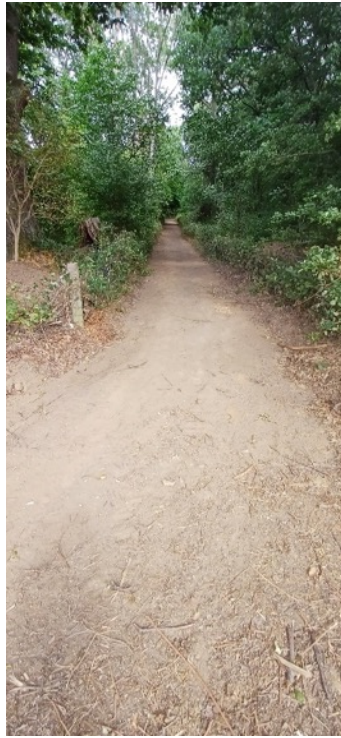
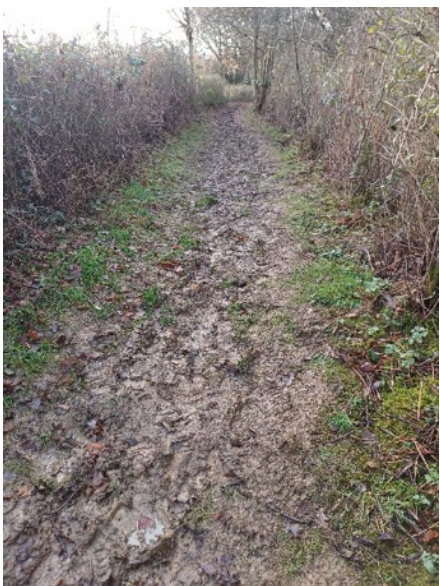
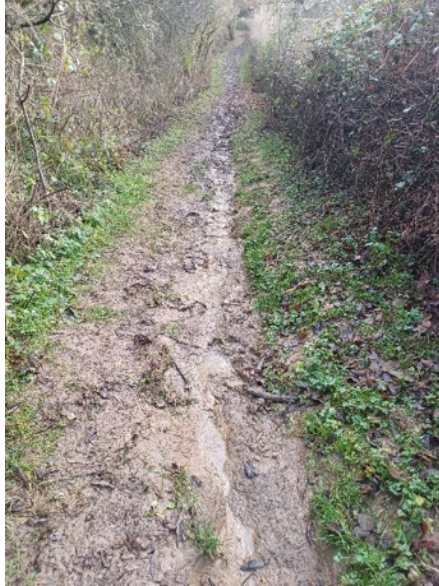
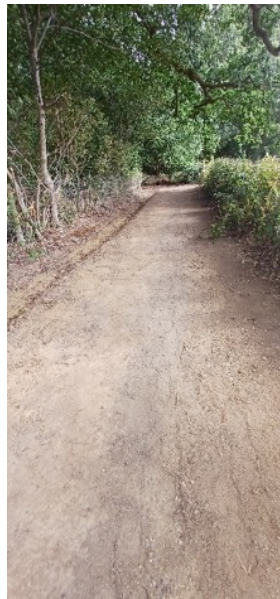
Above. The slope up the hill has been cleared of encroaching to increase the usable path width and prevent concentrated use that was contributing to gullying. It has been regraded down towards the newly dug ditch which will take excess water away from the path to try and prevent it running along the path as it was doing so before.

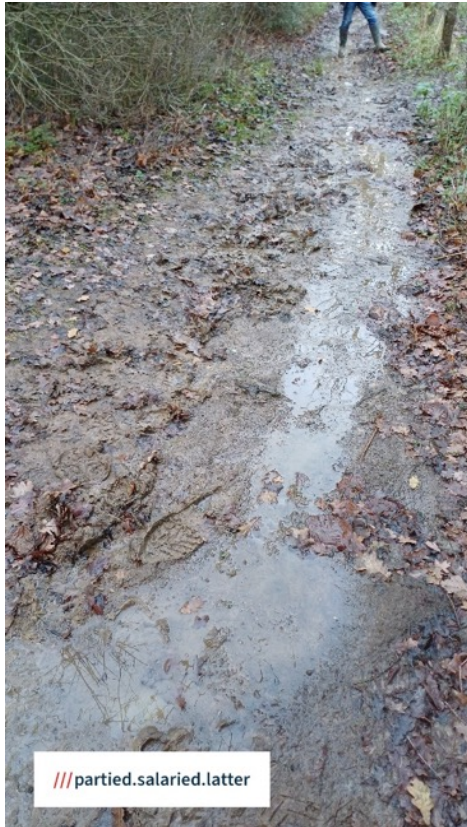
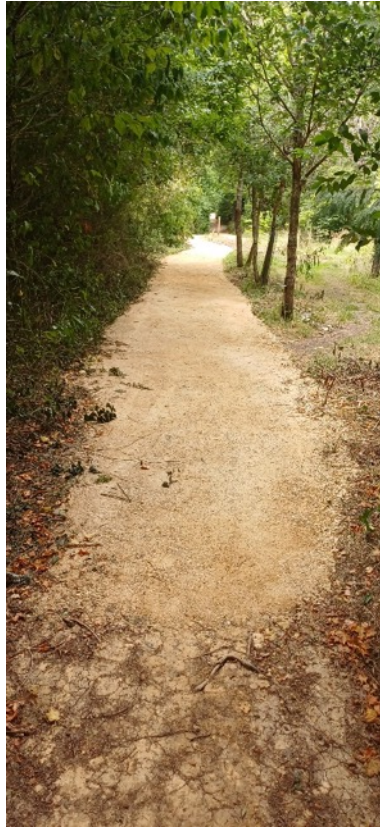
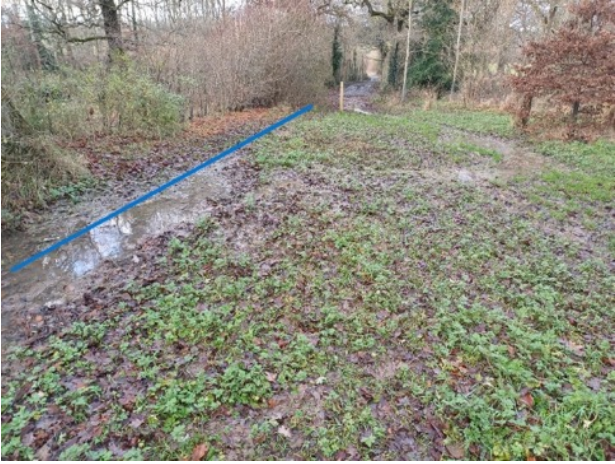
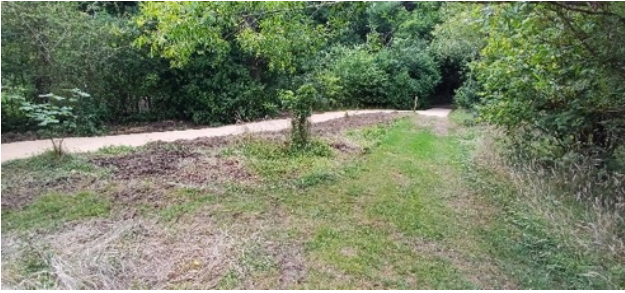
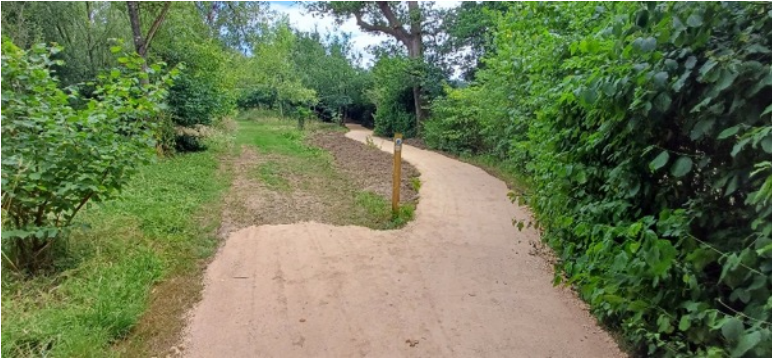
Above and on the next page: The bottom section of the path has been scraped and built up with stone to provide a higher surface for users to be above any flooded areas yet still allow the water to drain away naturally.
